Manhole Inspection Summary

Manhole # S41WW_008MH

Insp Date: **2/16/07 1:10 PM**

Location Address: **3212 LOCH RAVEN BLVD**

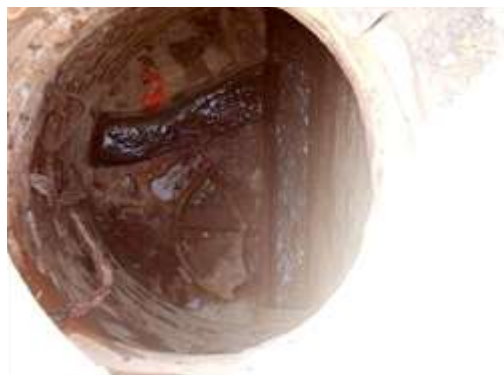
Top View

Barrel infiltration. Corroded and missing steps. Evidence of surcharge - Bench debris.

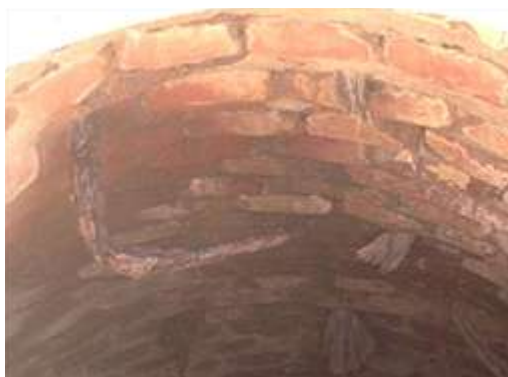
Defect

Frame leaks. Adjustment infiltration. Corroded and missing steps.

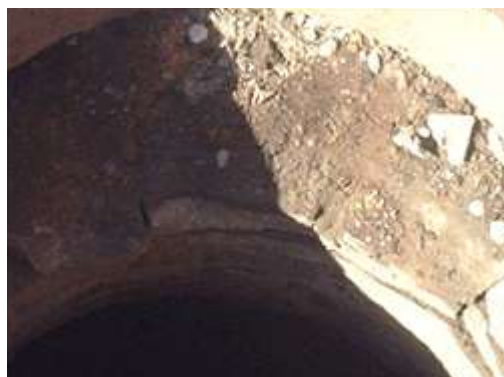
Defect

Frame leaks. Frame offset. Adjustment deterioration and infiltration.

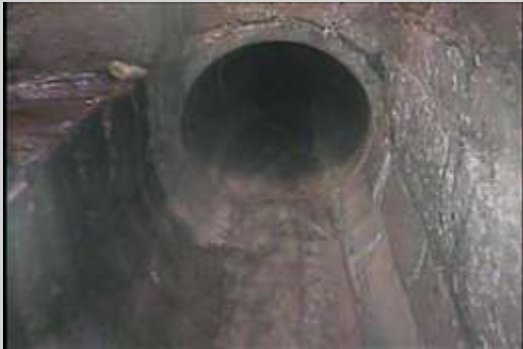
10 in. Circular Gravity Sewer Pipe Out @ 12 O'Clock

Infiltration: **None** Pipe Seal Cond: **Cracked**

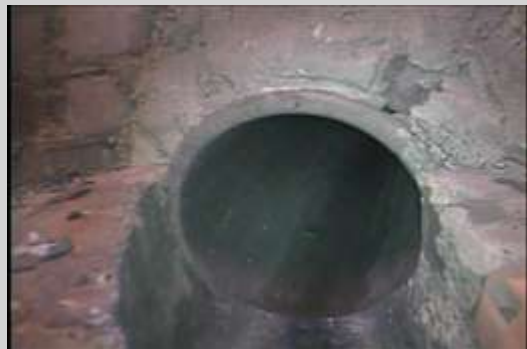
8 in. Circular Gravity Sewer

Infiltration: **Evidence**
